Inspection Report of Structural Stability Assessment of Kendriya Vidyalaya- No. 1 Neemuch

Dr. Neelima Satyam
Associate Professor and Head
Department of Civil Engineering
Indian Institute of Technology Indore, Madhya Pradesh (India)

July 2021

1. About Project:

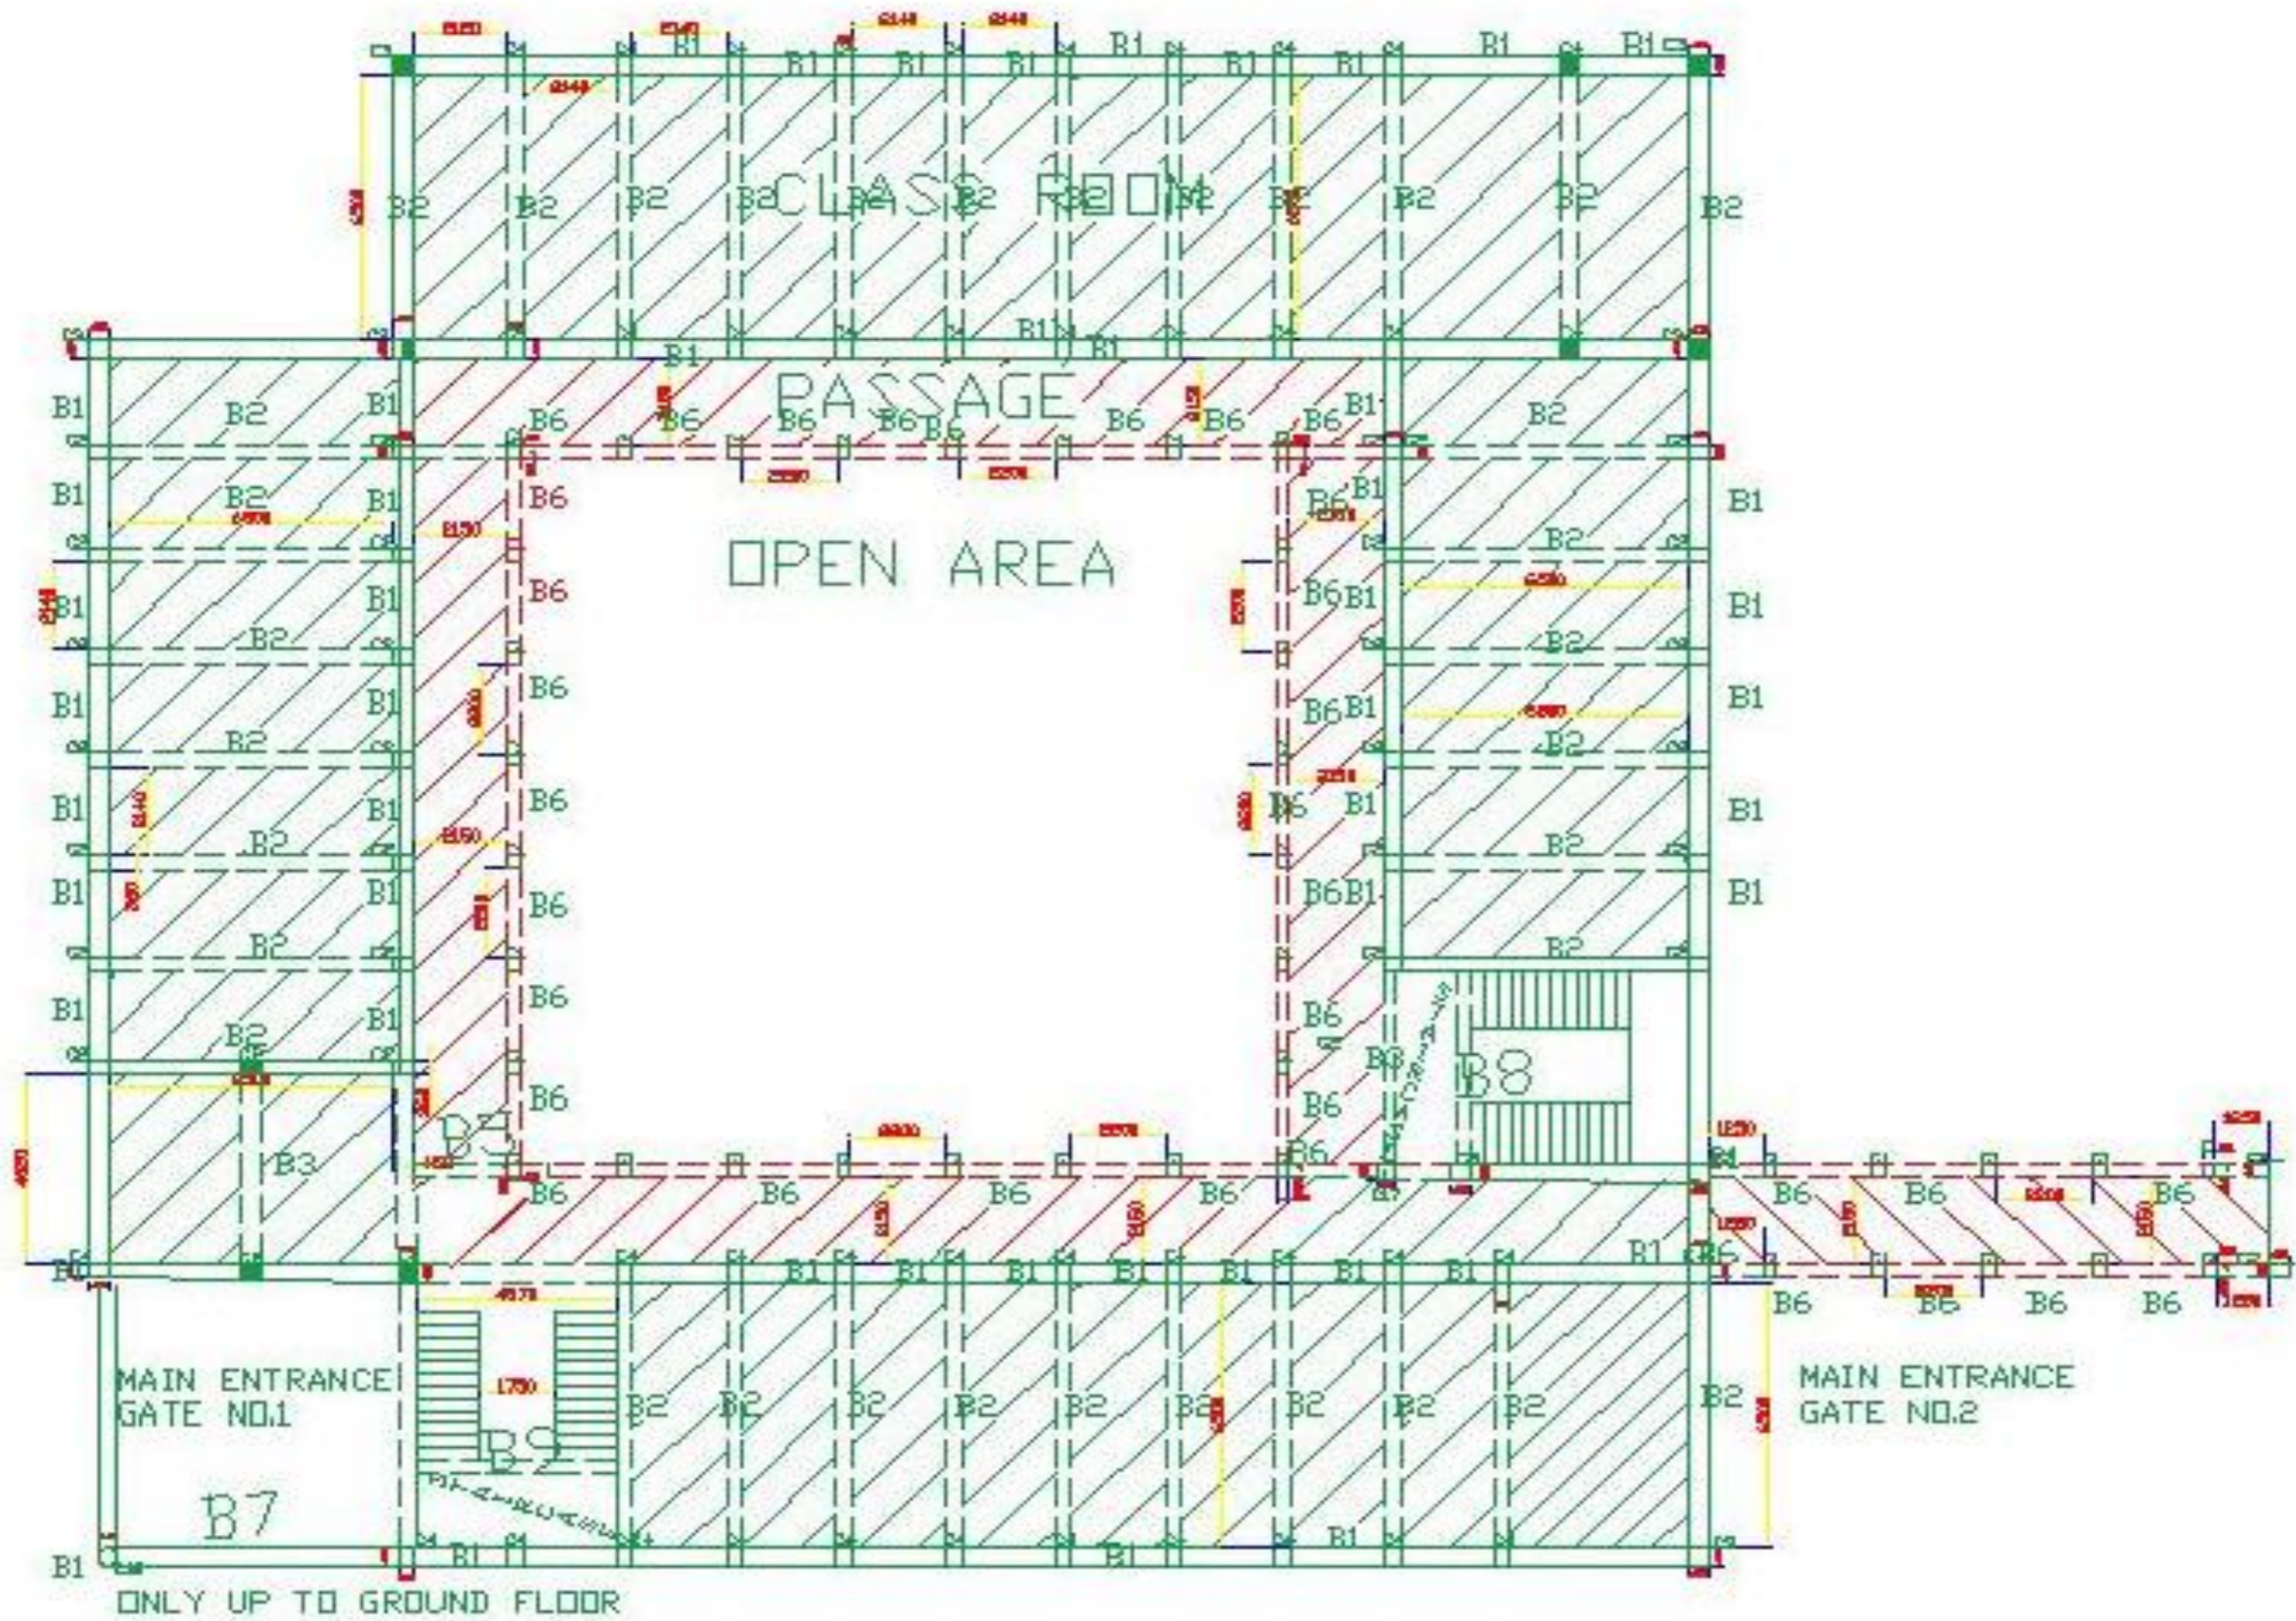
Figure 10: Structural Failure in RCC member of Block A (Marked in Red Colour)

- Block A and B are constructed with stone masonry, and it has been observed that the existing condition of both blocks is fine, however the block A and B having seepage issues. The seepage is considered a serious cause for the continuous structural damage; therefore, it is highly recommended to take necessary remedies on the immediate basis in both A and B blocks. Also, some minor cracks in the Block A and B are also observed; therefore, it is suggested to take structural strengthening measures. The unsafe RCC structure has been marked with red color in the drawing.

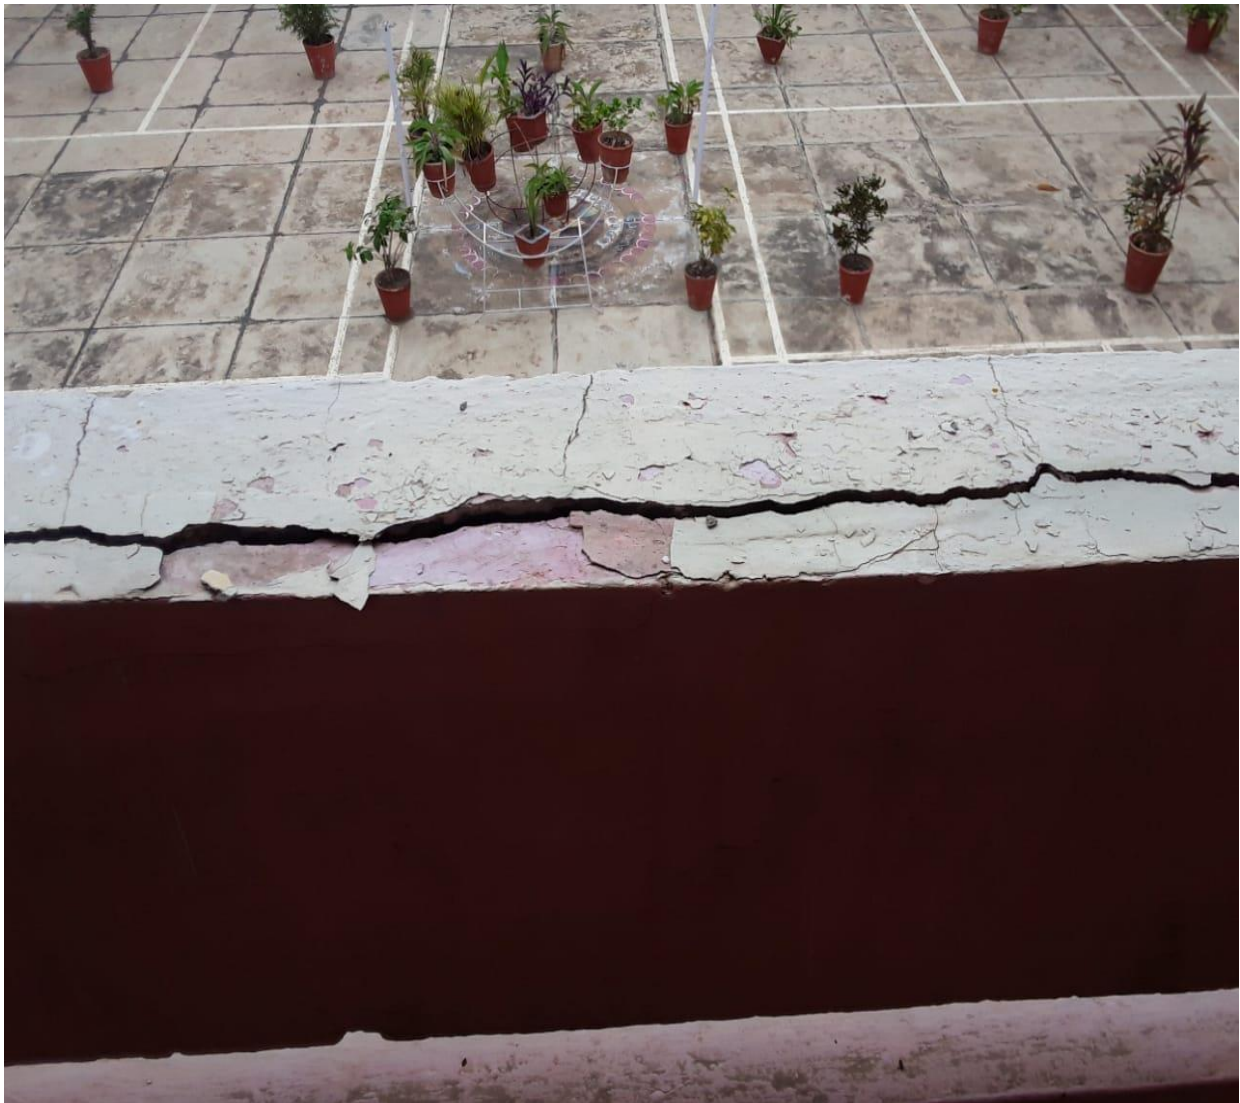
Figure 11: Structural Damage in the beam of old school building

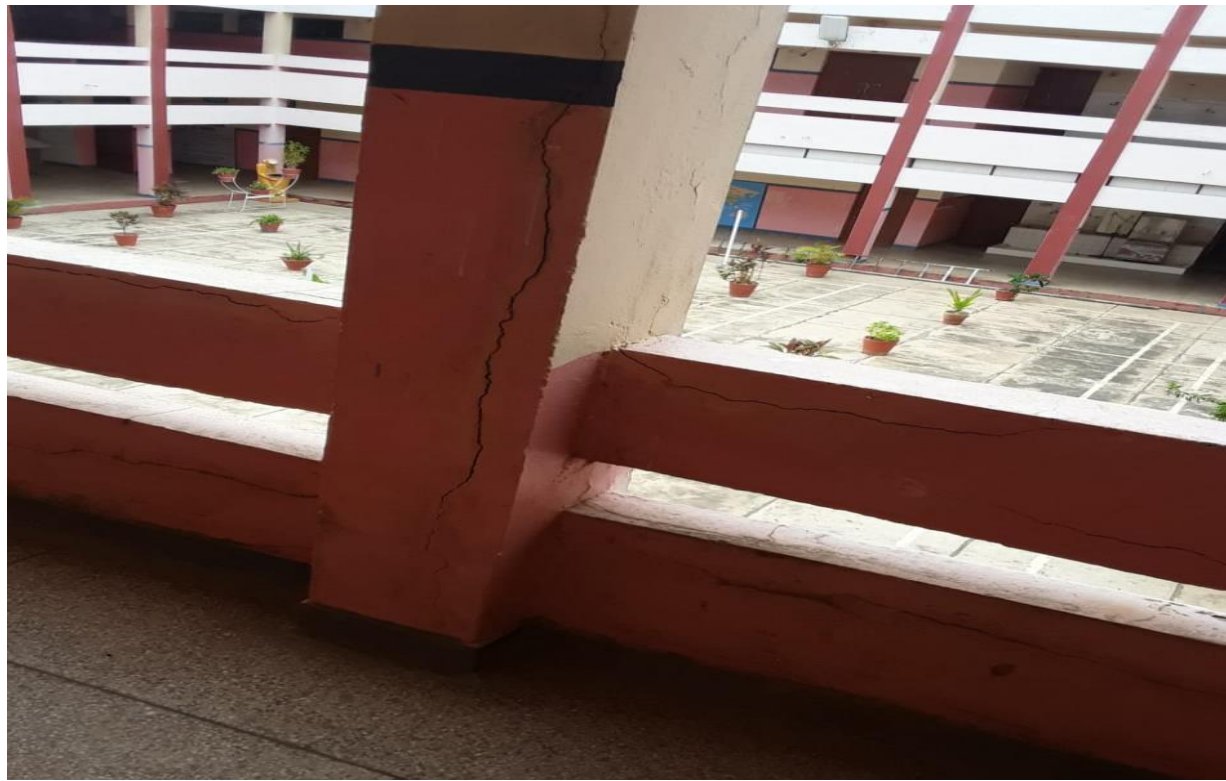
Figure 12: Structural Damage in the Column of old school building

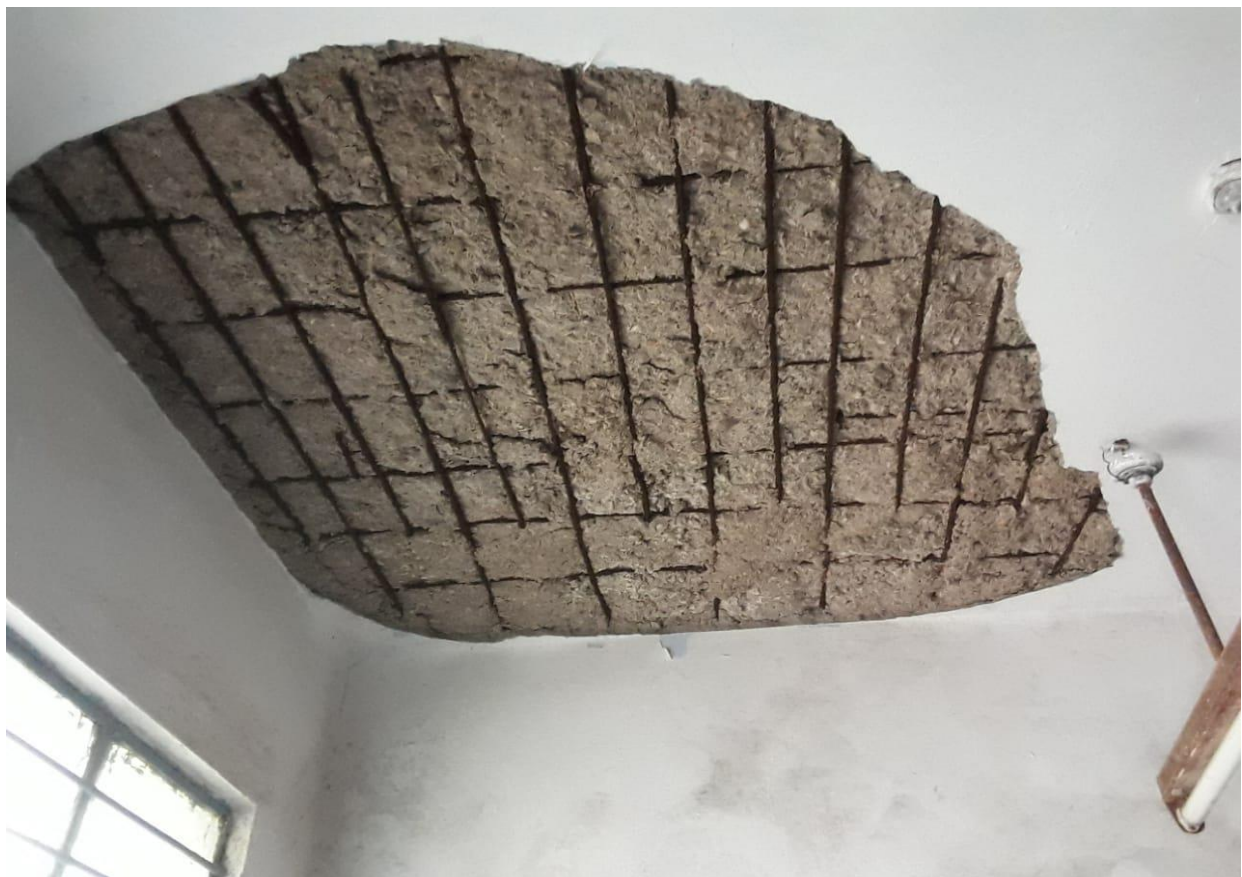
Figure 13: Failure in the roof of an inside school building

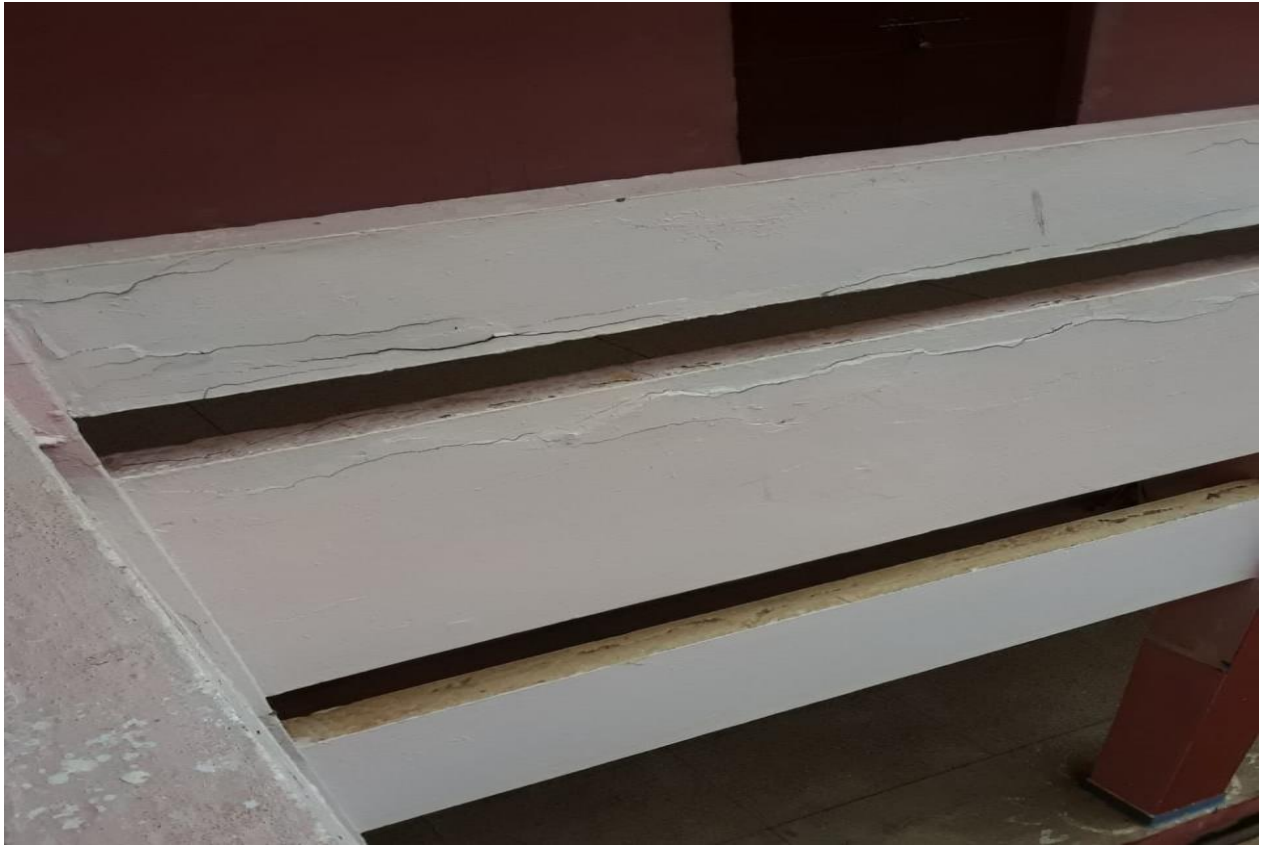
Figure 14: Damage in the inside passage area of old school building beam

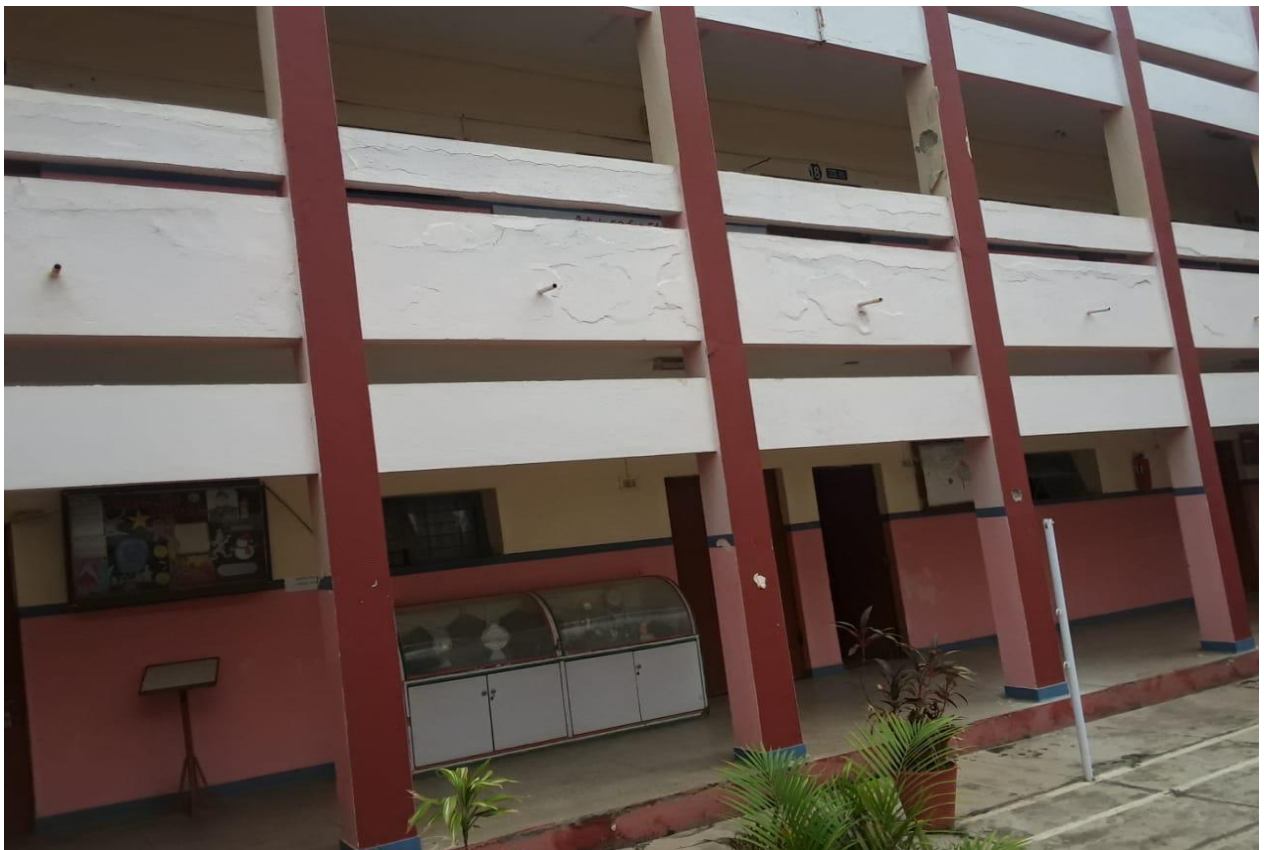
Figure 15: Structural Damage in passage area of old school building (Block A)

- The old building was divided into blocks A and B in this report. Block A and B are constructed with stone masonry, and both the blocks are connected with the RCC structure passage (near Gate no. 02). The structural stability assesmsnet of the RCC structure of the passage has been carried out, and it has been observed that the existing condition of the RCC passage is not suitable for the operation. The beams and columns of the RCC structure are damaged, and several significant cracks have been observed. The non-destructive results obtained show the doubtful condition of the RCC structure, and therefore, it is advised not to consider this section for the operation on an immediate basis. The RCC section of the building should be demolished, and a new passage should be constructed for connection blocks A and B. The retrofitting of the RCC structure is not recommended, considering the poor structural stability.

Based on the detailed field observations and non-destructive results obtained, it is clear that structural stability of the RCC structure (passage between block A and B) is very poor; therefore, it is advised not to consider this section for the operation on an immediate basis. The RCC section of the building should be demolished, and a new passage should be constructed for connecting blocks A and B. Block A and B are constructed with stone masonry and having a well-maintained condition; however, the block A and B having seepage issues. The seepage is considered a severe cause for continuous structural damage; therefore, it is highly recommended to take necessary remedies immediately. The projected portion of the windows/lintels in old buildings has the poor condition; consequently, it should be demolished and reconstructed. Block A having corrosion issues in the reinforcement bar; therefore, it is advised to take adequate remedy for the repair work. Block C (primary section) having good structural stability at the present condition; and

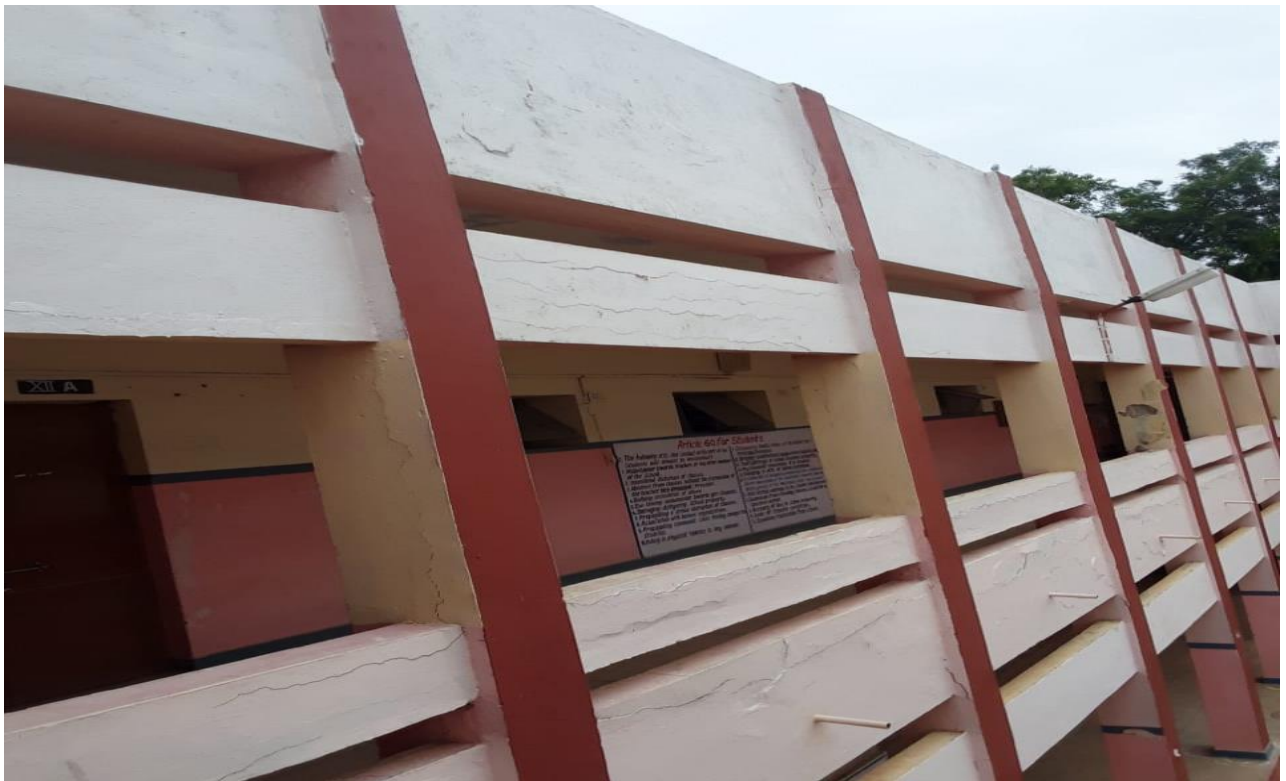
Figure 16: Major damages in the RCC member of School building

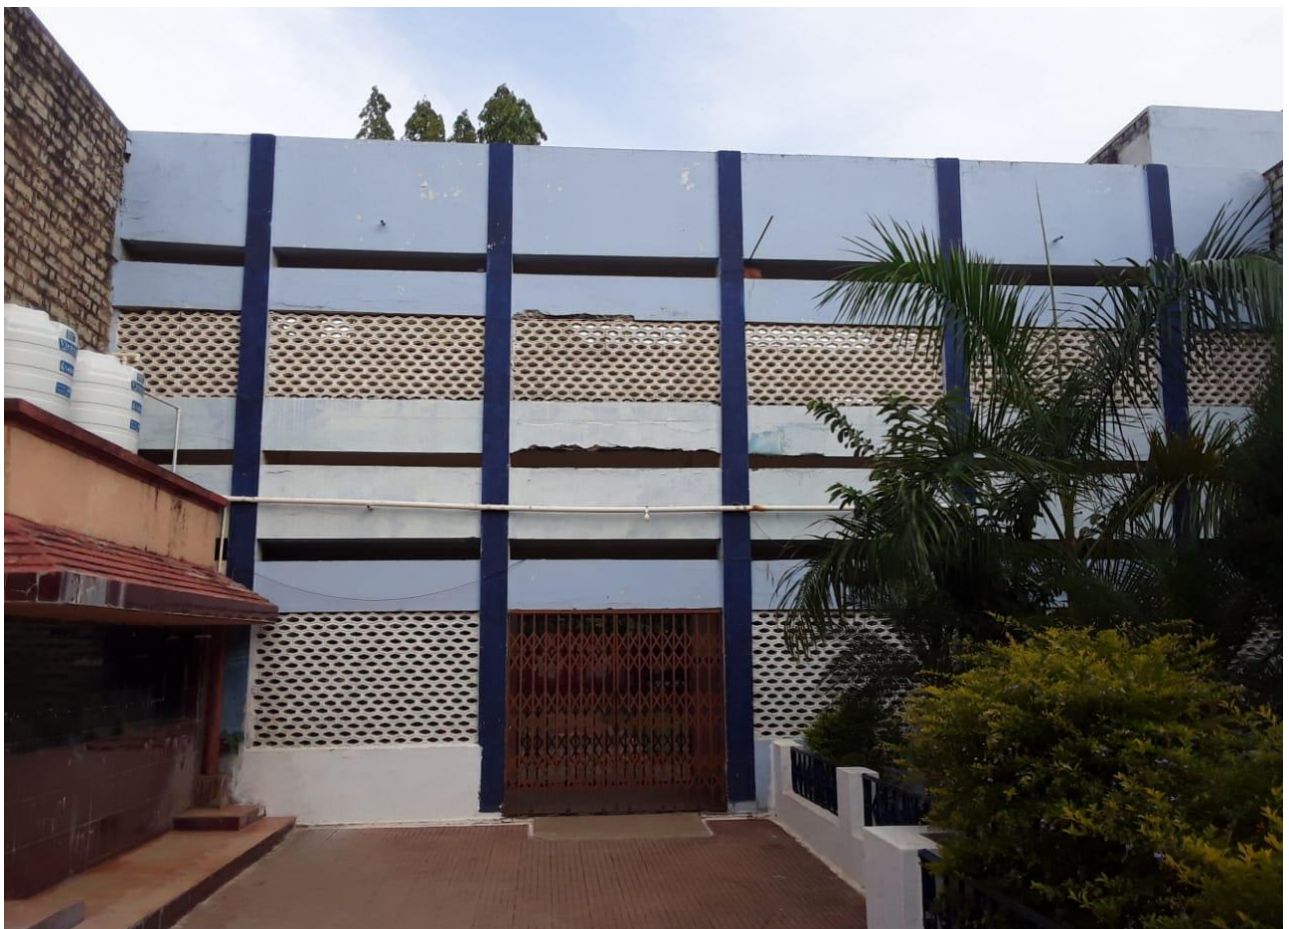
Figure 17: Structural Damage in the RCC member of passage area

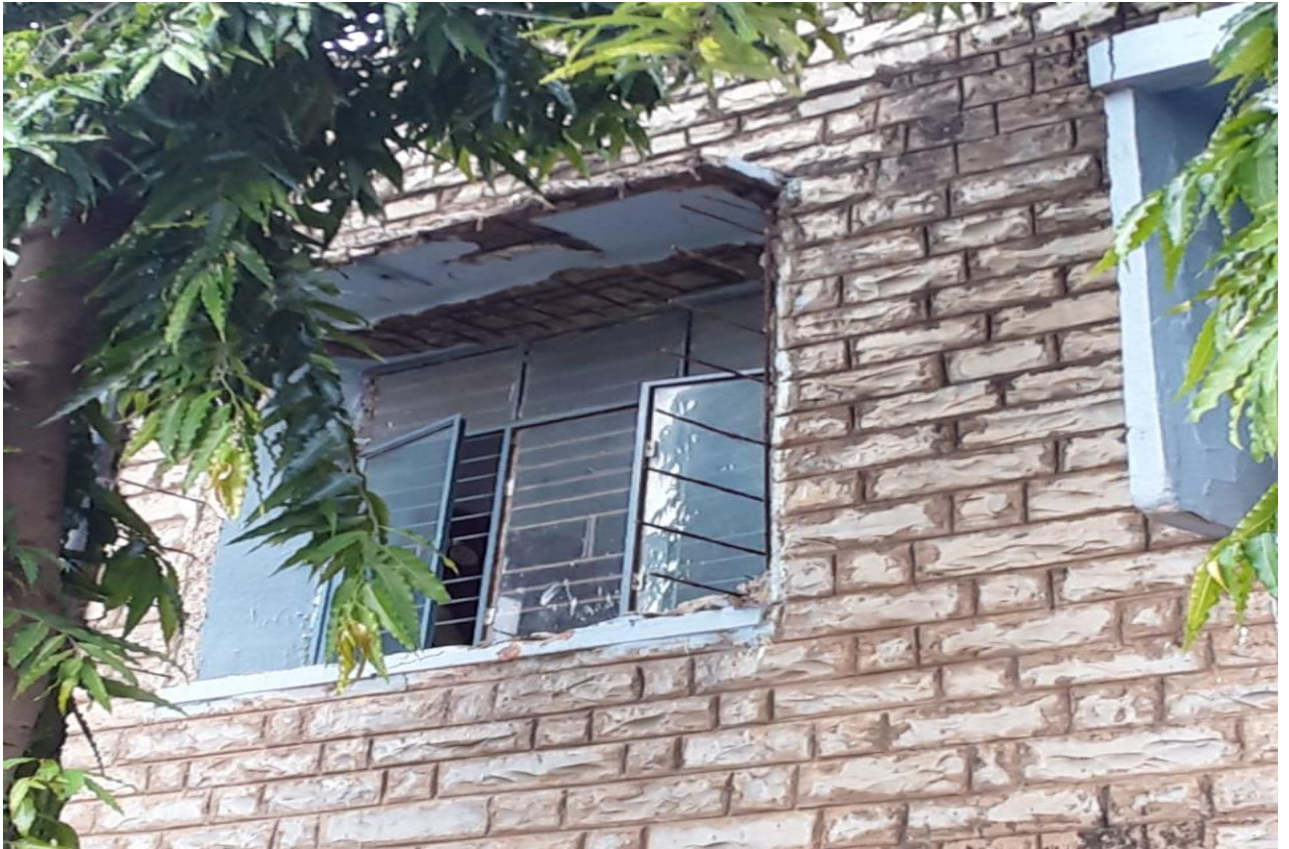
Figure 18: Reinforced bars exposed to open environment in a backside school building

- In block A, corrosion of the reinforcement bar occurred due to the deterioration of the covering of the structural elements. Corrosion in the structural elements of the building has reduced the load-carrying capacity of the building, and the structural stability of the building has become a serious concern. Since corrosion has also occurred in the internal reinforcement. It is suggested to adopt suitable remedial methods.

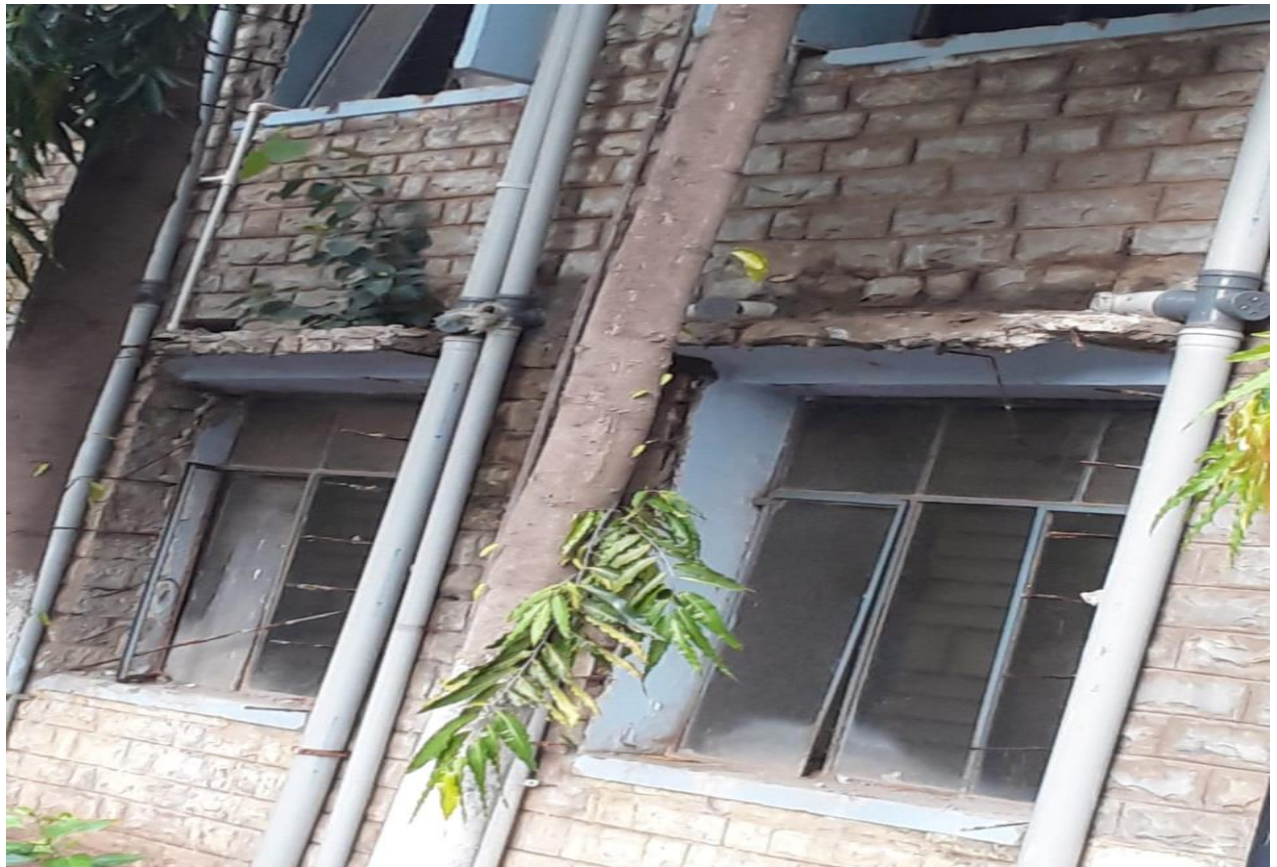
Figure 19: Damages in the projection of windows backside school building

- The projection of lintel and windows in blocks A and B were found in very poor condition. It is suggested to dismantle all the projection of windows/lintel and repair it.

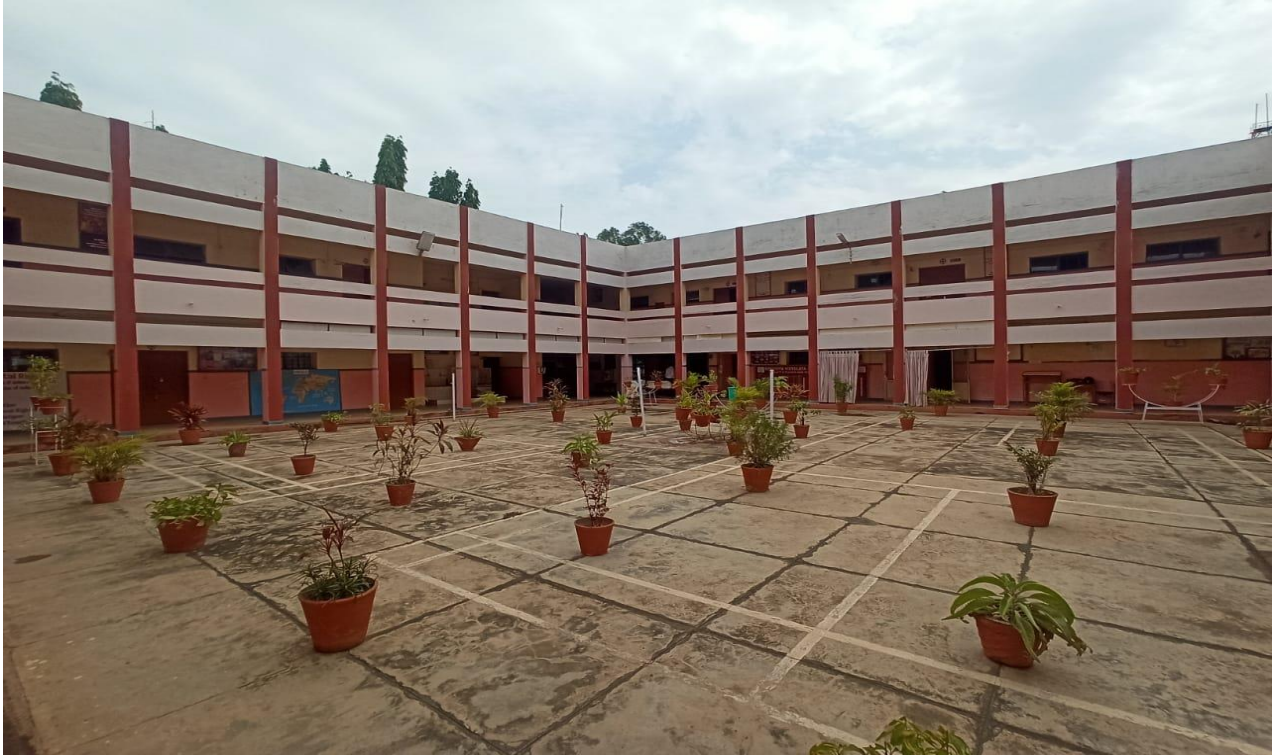
Figure 20: Structural Damages in the RCC member of old school building (Passage Area)

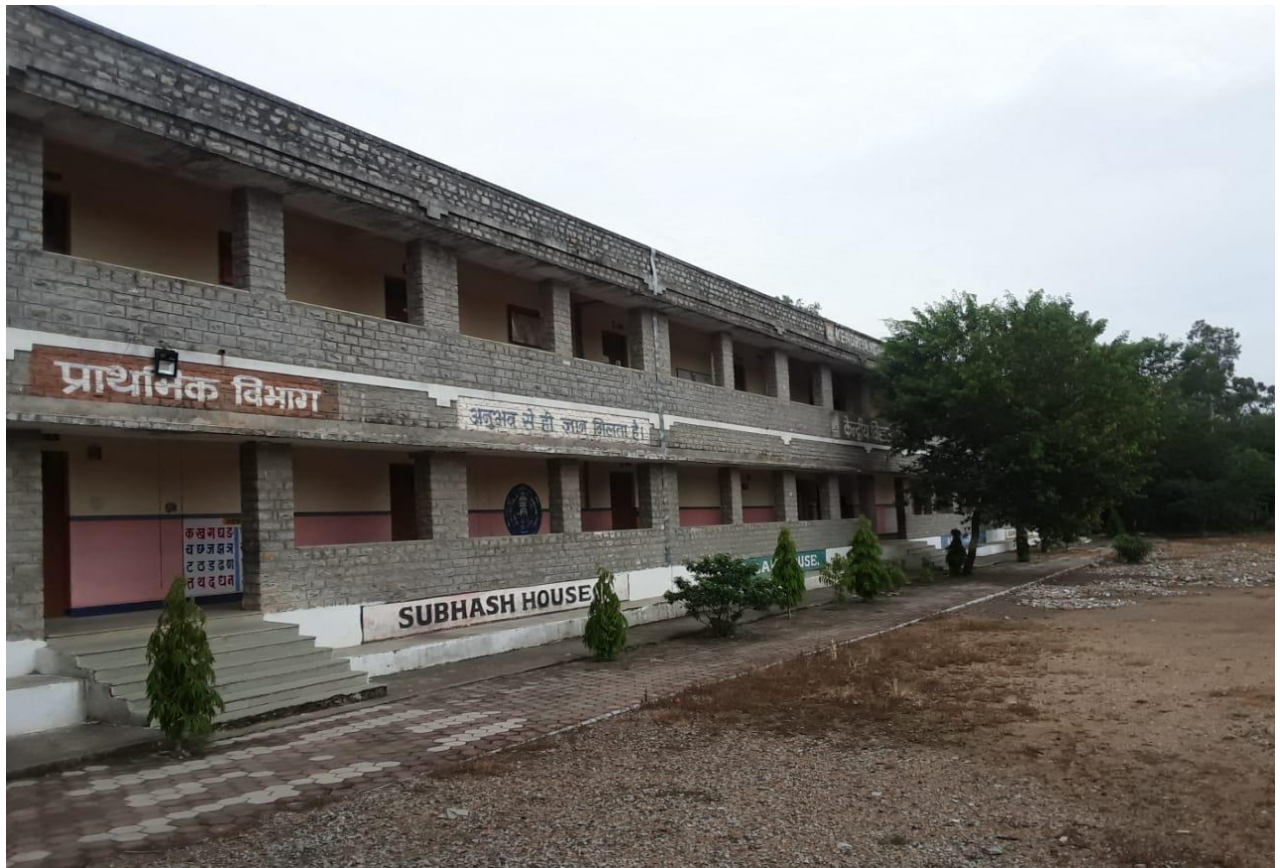
Figure 21: Sound structure of Primary Department building

however, the maintenance work of the building needs to be carried out. The cleaning of the expansion joint of Block C is recommended, and damp-proof course should be provided in expansion joints.
